ENVIRONMENTAL QUALITY RESOURCES, L.L.C.

October 25, 2001

RE: Stream Stabilization work completed at the Clarksburg site
RMS 01RMS5222A
00-02465-13
SC# 203190/SM#1-95042

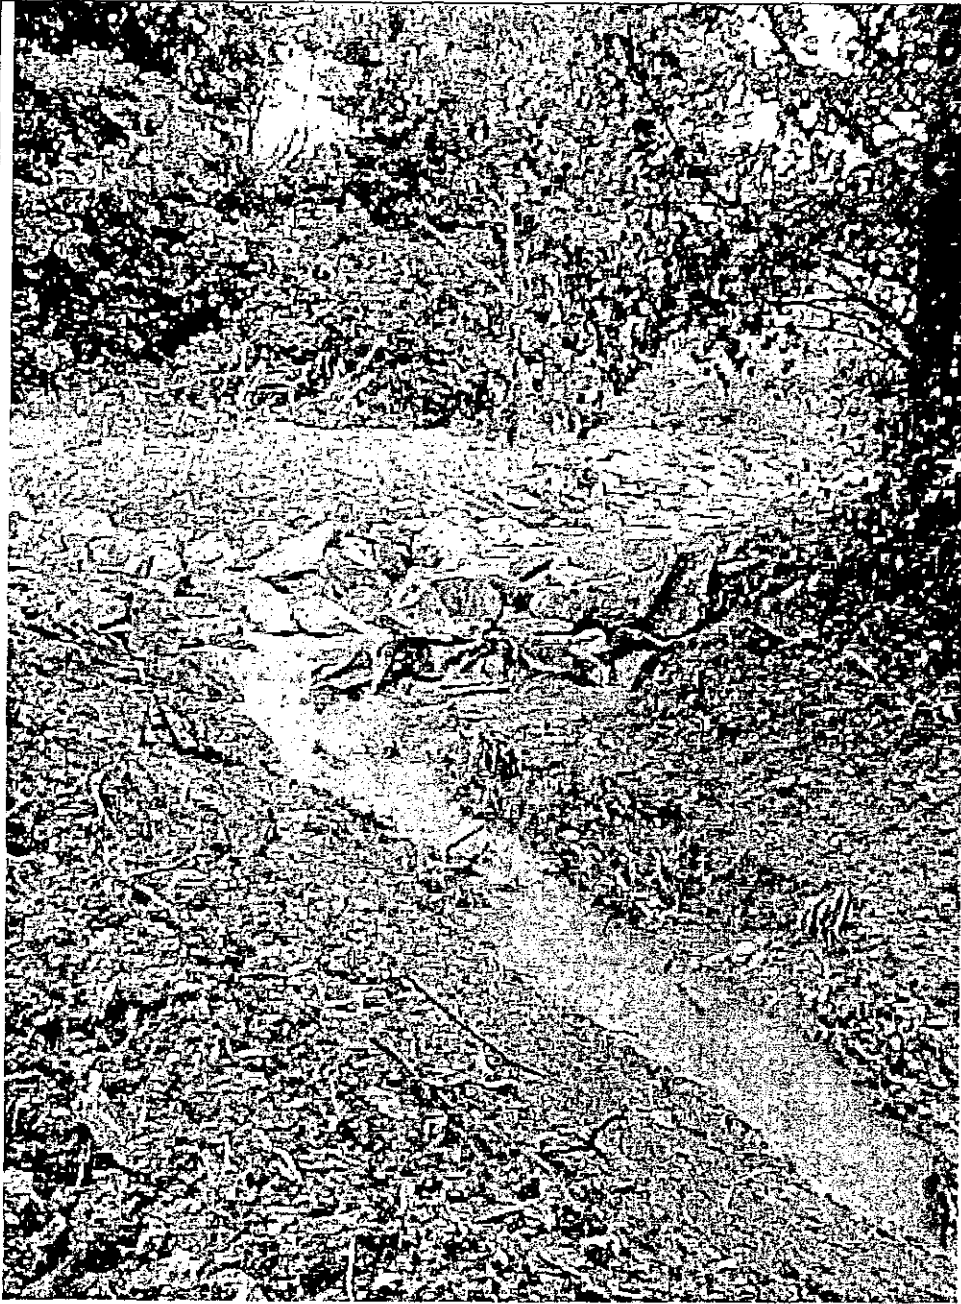
PICTURE1: PARTIALLY INSTALLED RIP RAP AT CONFLUENCE AFTER LARGE STORM
EVENT; SEDIMENT LADEN WATER IS FROM UPSTREAM SEDIMENT CONTROL
BASIN

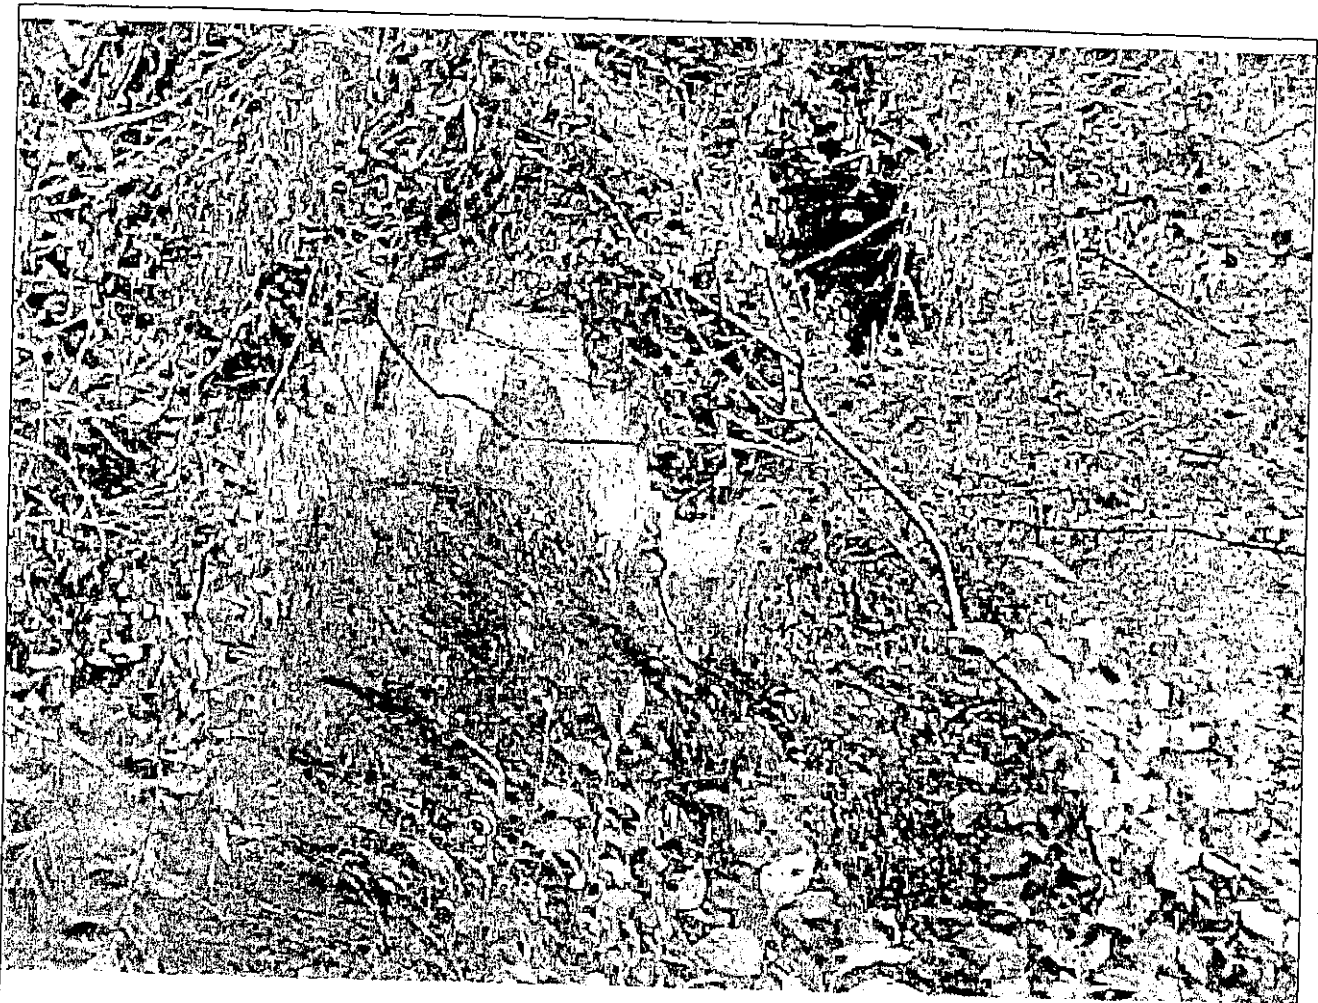
PICTURE 3; LOWER ERODED GULLY AFTER STORM BUT PRIOR TO STEP POOL INSTAATION

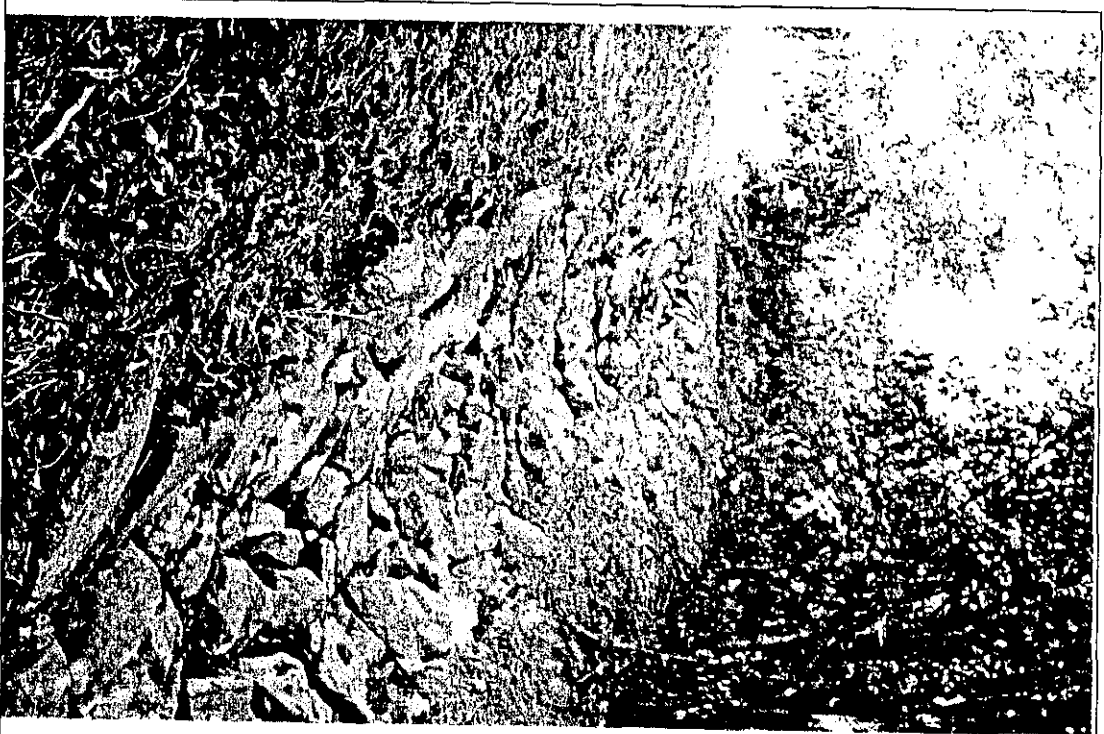
PICTURE 4: SAME AREA AS SHOWN IN PICTURE 3 BUT STEP
POOLS ARE INSTALLED

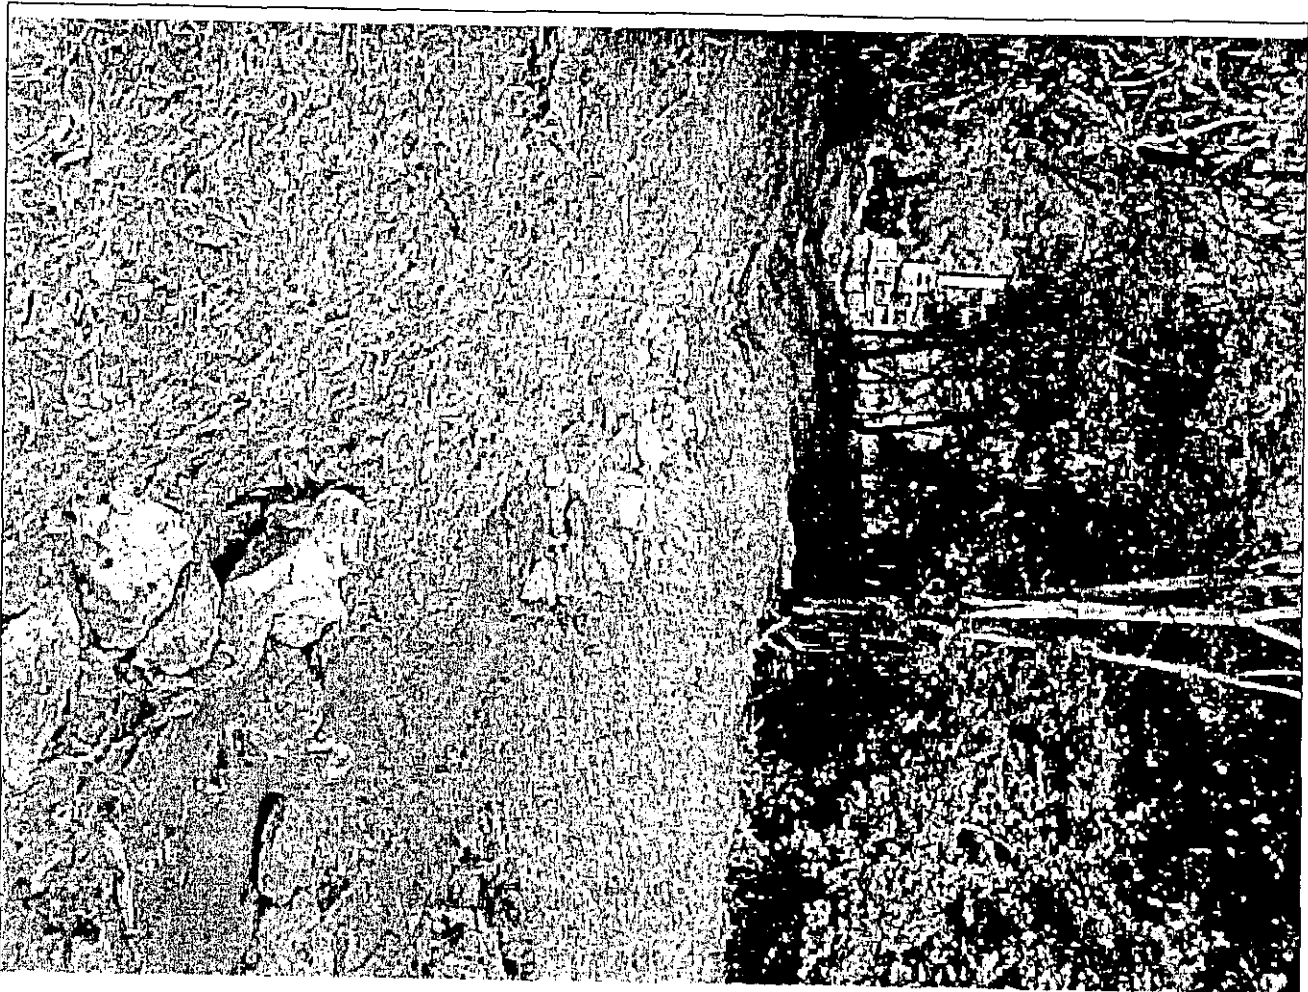
PICTURE 5: STEP POOLS INSTALLED BELOW SEWER CROSSING
